# Manhole Inspection Summary

# Manhole # S39A2\_023MH

Insp Date: **12/21/07 8:38 AM**

**Location** Address: **3830 Brooklyn Ave**

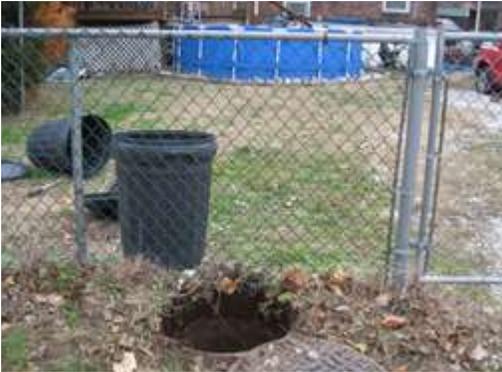
Location View

6th-brooklyn alleyway

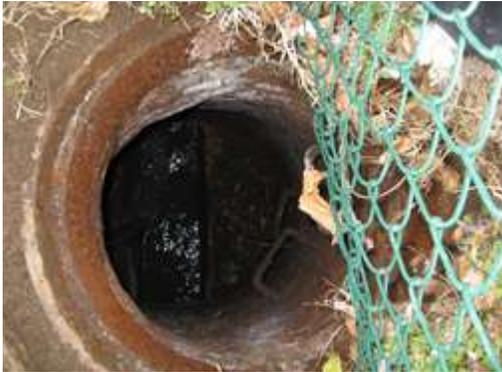
Top View

steps

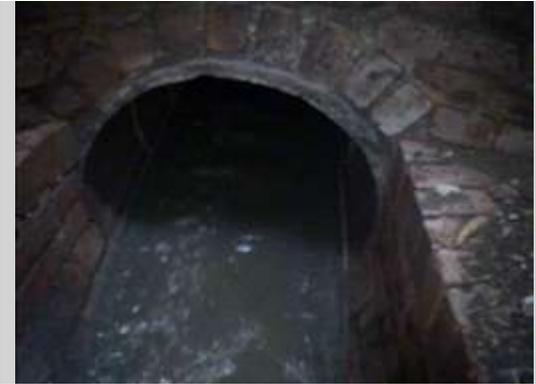
**12 O'Clock Outflow**

**21 in. Circular Gravity Sewer**  
**Pipe Out @ 12 O'Clock**

Pipe Height: **24** (in.) Rod and Bar (Angled)  
Pipe Material: **Clay**  Pipe Lined  
Invert Depth: **11.62** (ft.) Flow Characteristics: **Fast**  
Deposits:  None  Mud  Sludge  Debris  Grease  
Silt Depth: (in.) Deposits Extent:  
Infiltration: **None** Pipe Seal Cond: **Sound**

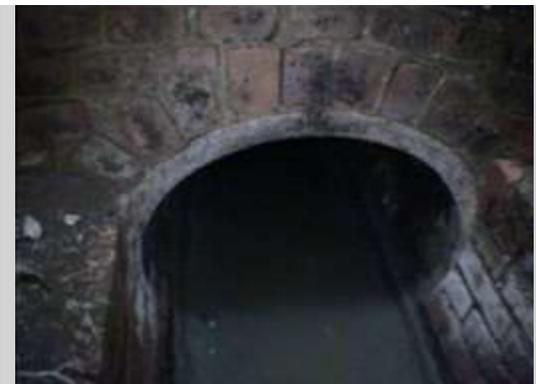
**6 O'Clock Inflow**

**18 in. Circular Gravity Sewer**  
**Pipe In @ 6 O'Clock**

Pipe Height: **22.8** (in.) Rod and Bar (Angled)  
Pipe Material: **Clay**  Pipe Lined  
Invert Depth: **11.28** (ft.) Flow Characteristics: **Fast**  
Deposits:  None  Mud  Sludge  Debris  Grease  
Silt Depth: (in.) Deposits Extent:  
Infiltration: **None** Pipe Seal Cond: **Sound**

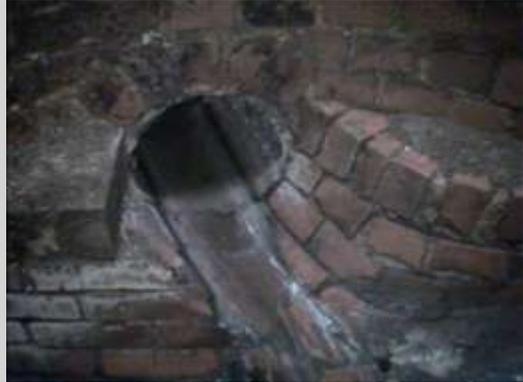
9 O'Clock Inflow

10 in. Circular Gravity Sewer

Pipe Height: **9.6** (in.) Rod and Bar (Angled)

Pipe Material: **Clay**  Pipe Lined

Invert Depth: **10.32** (ft.) Flow Characteristics: **Fast**

Infiltration: **None** Pipe Seal Cond: **Sound**
